## Product Analysis Report

Work Order:	238252	Quantity Received:	81
Customer:	Novus T.D LTD	Quantity Inspected:	13
PO Number:	1812488	Report Date/Time:	3/6/23 11:49 AM
Prepared By:	Liuxiangmin	Approved by:	Jose Rey Redoblado

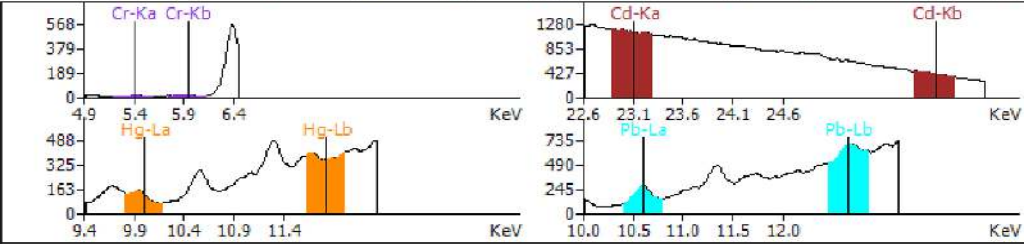
Note: ND means Concentration ≤ 2ppm					
XRF tests on surface only.					
The content of "Cr" or "Br" is the total amount of this element. The reading data does not represent.
